**Re: DRAFT #1 (August 3, 2022)
Report of Findings – Phase I Environmental Site Assessment
8 Reserve Lands, Xenigwet'in First Nations Government
Nemiah Valley, BC
Project No. 16287**

DRAFT #1 (August 3, 2022)
Report of Findings
Phase I Environmental Site Assessment

**8 Reserve Lands, Xeni Gwet'in First Nations Government
Nemiah Valley, BC**

**Project No. 16287
August 2022**

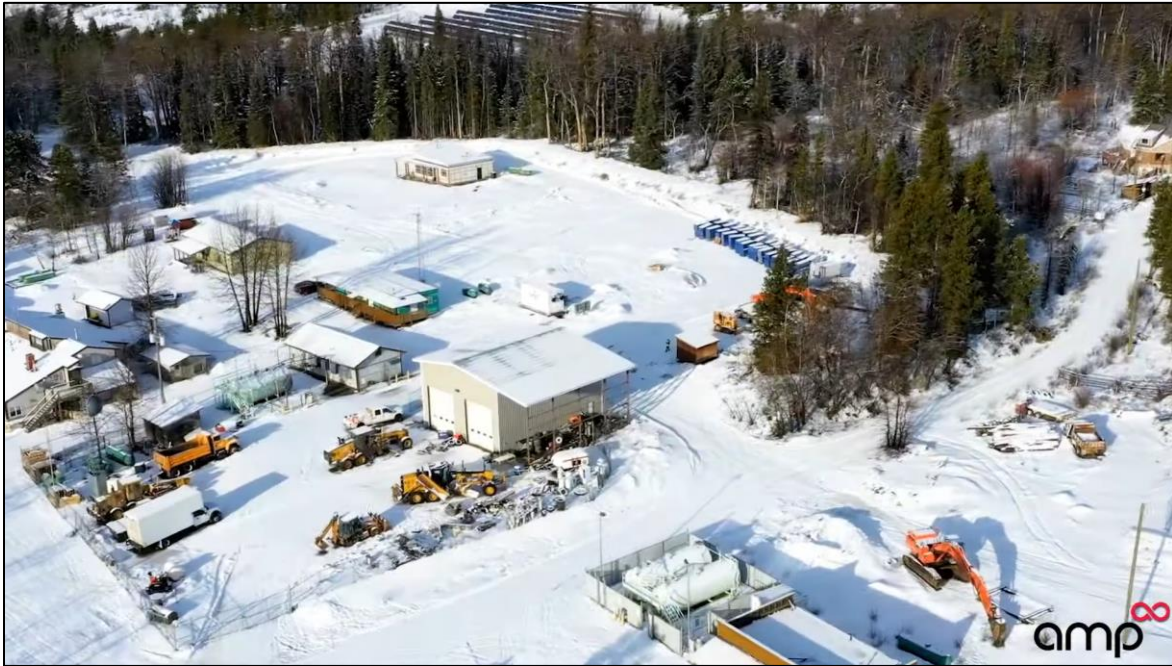
Photograph 1: Enterprise Works Yard (centre), Enterprise gas station ASTs (bottom right), and Xeni Gwet'in Band Office (centre left) on Lohbiee 3 looking northwest ¹

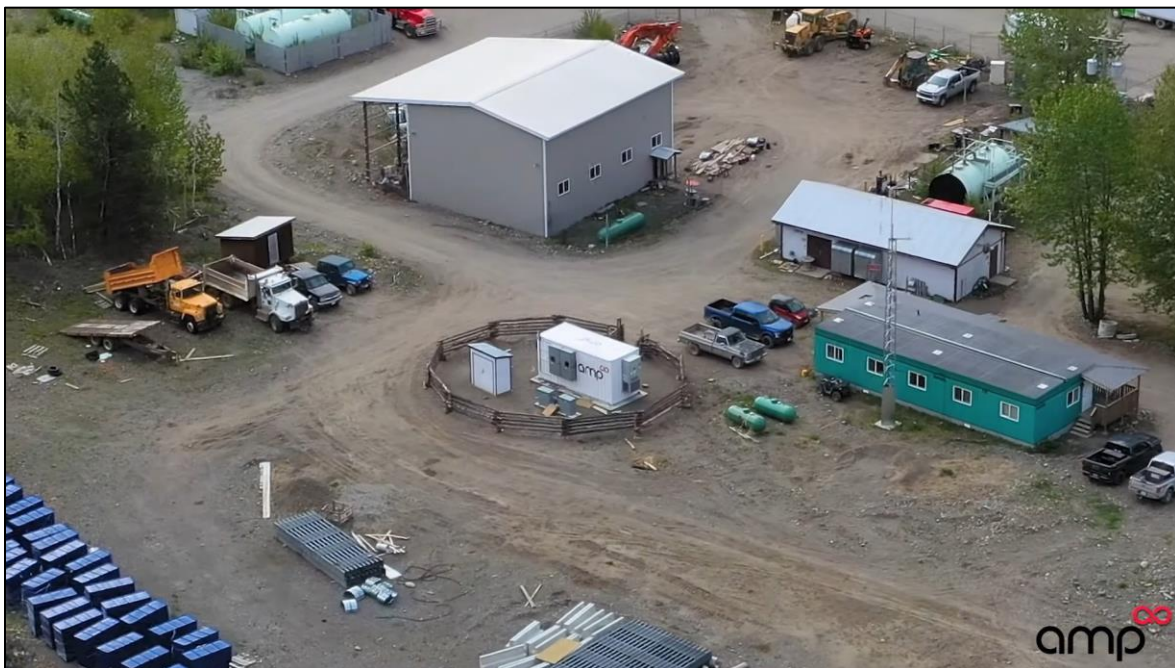
Photograph 2: Enterprise Works Yard (top centre) looking southeast ¹

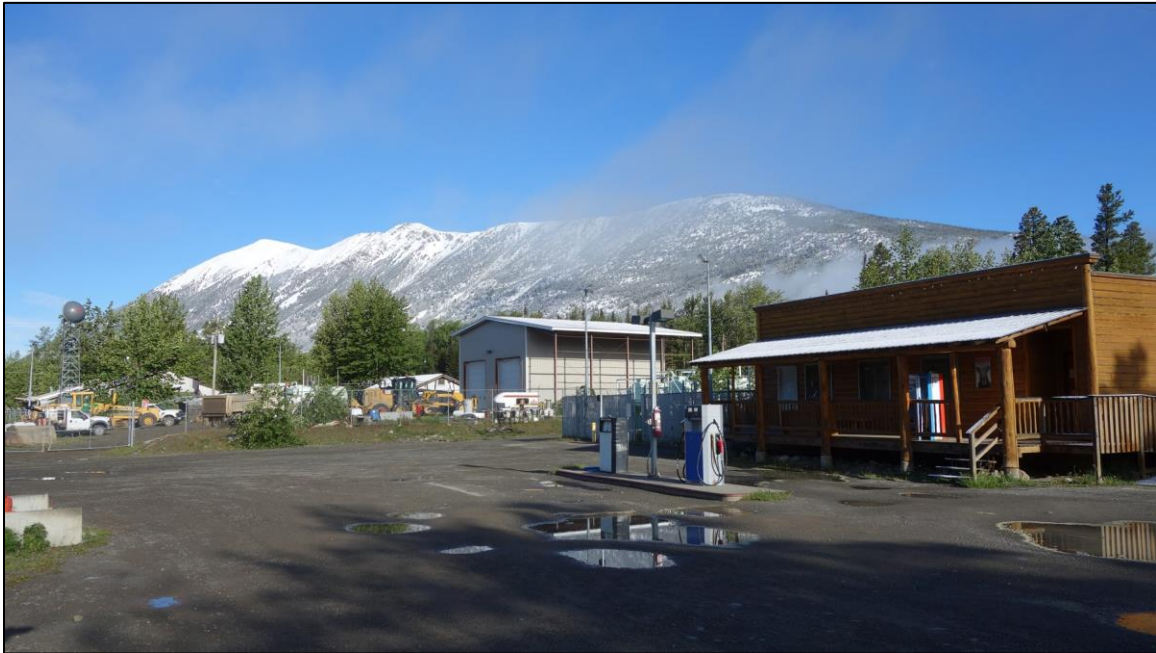
Photograph 3: Enterprise gas station (right foreground) Enterprise Works Yard (centre midground), and Xeni Gwet'in Band Office (left background) on Lohbiee 3 looking northwest

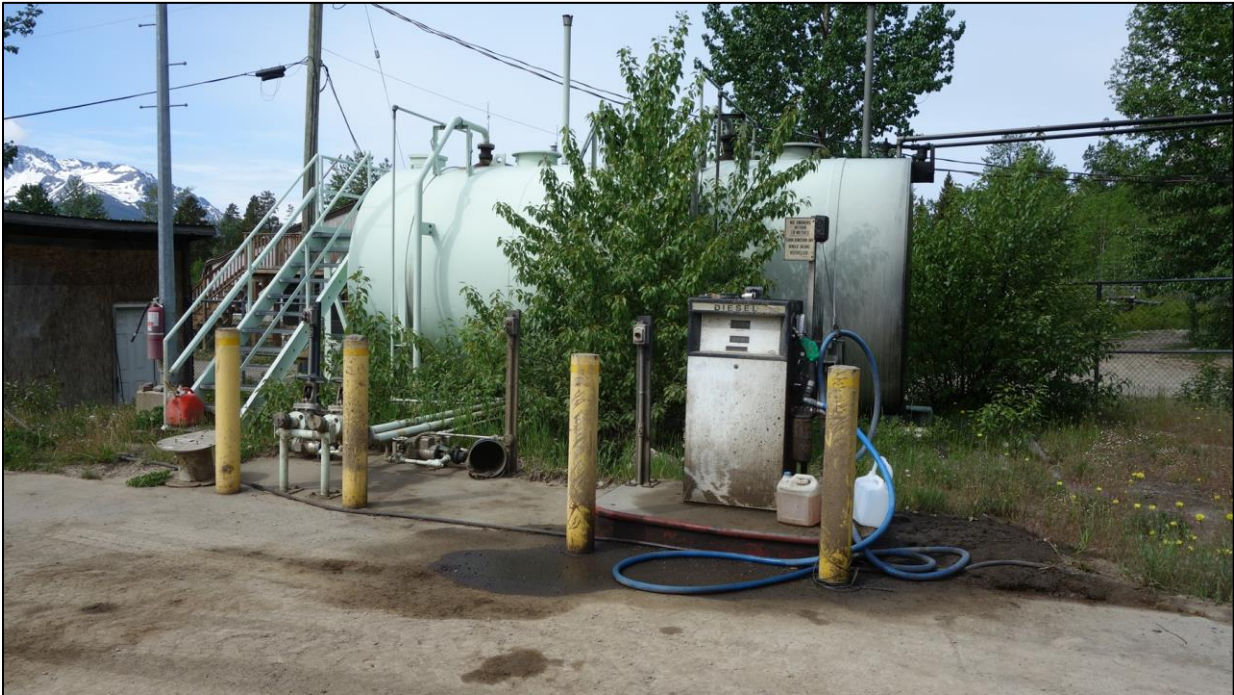
Photograph 5: Diesel AST for powerhouse/generators and Enterprise Works Yard fuel pump, located northeast of the Band Office, looking southwest

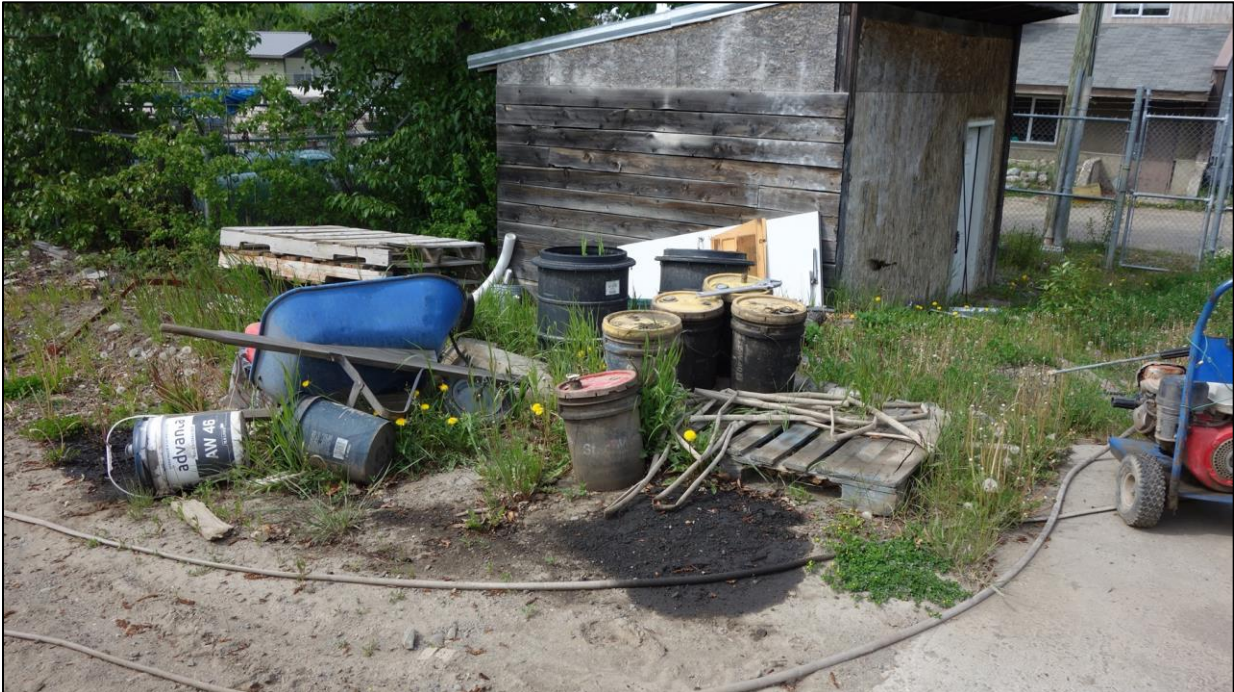
- The IEMS database indicates the file for the Tatla Service Station (FCSI 05055002) was closed in 2003.
- Heavy equipment has been stored, maintained and refuelled in the Enterprise Works Yard since the early 2000s, and in 2022, over two hundred 20 L containers of waste oil were observed to be stored, without cover, over gravel in the storage yard. Some of the containers did not have lids or were tipped over and associated dark staining was observed (~20 m²). Additional soil staining was observed (~5 m²) adjacent to the diesel fuel pump.

Photograph 6: Stains and waste oil adjacent to pressure washer on Enterprise Works Yard fuel pump pad, looking southwest

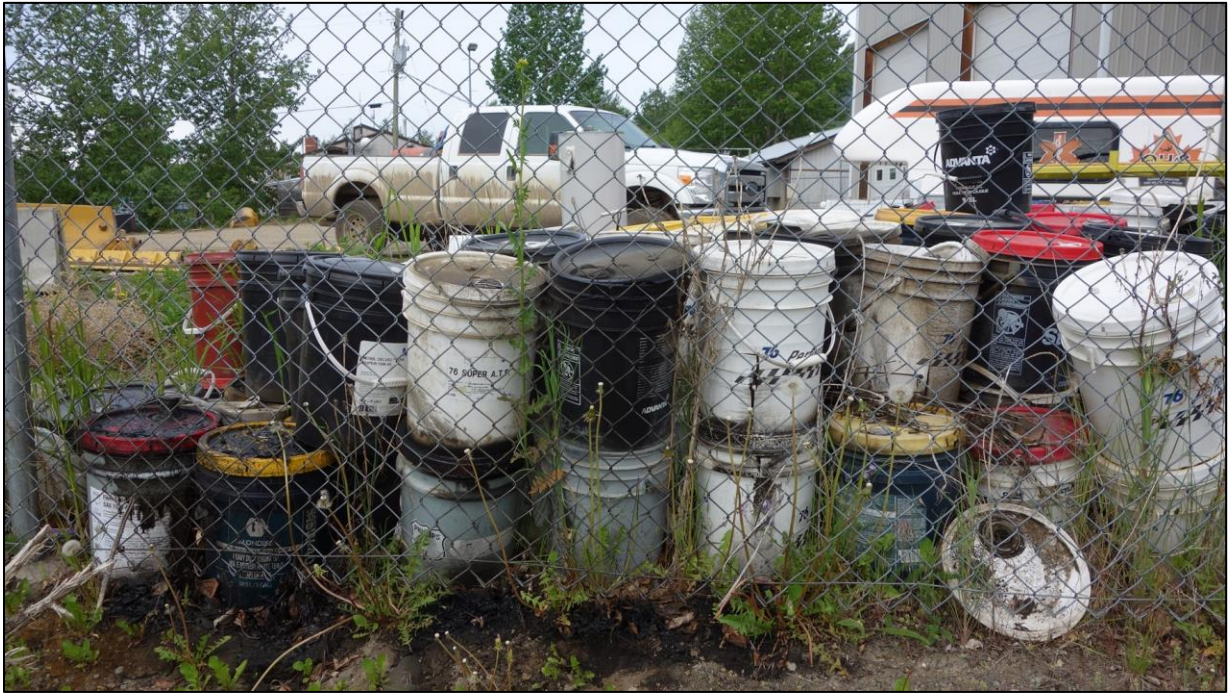
- Approximately fifty additional 20 L containers of new oil and/or waste oil were observed in the repair shop with underlying staining, including minor staining adjacent to the floor drain.

Photograph 7: Waste oil storage and staining in Enterprise Works Yard looking west

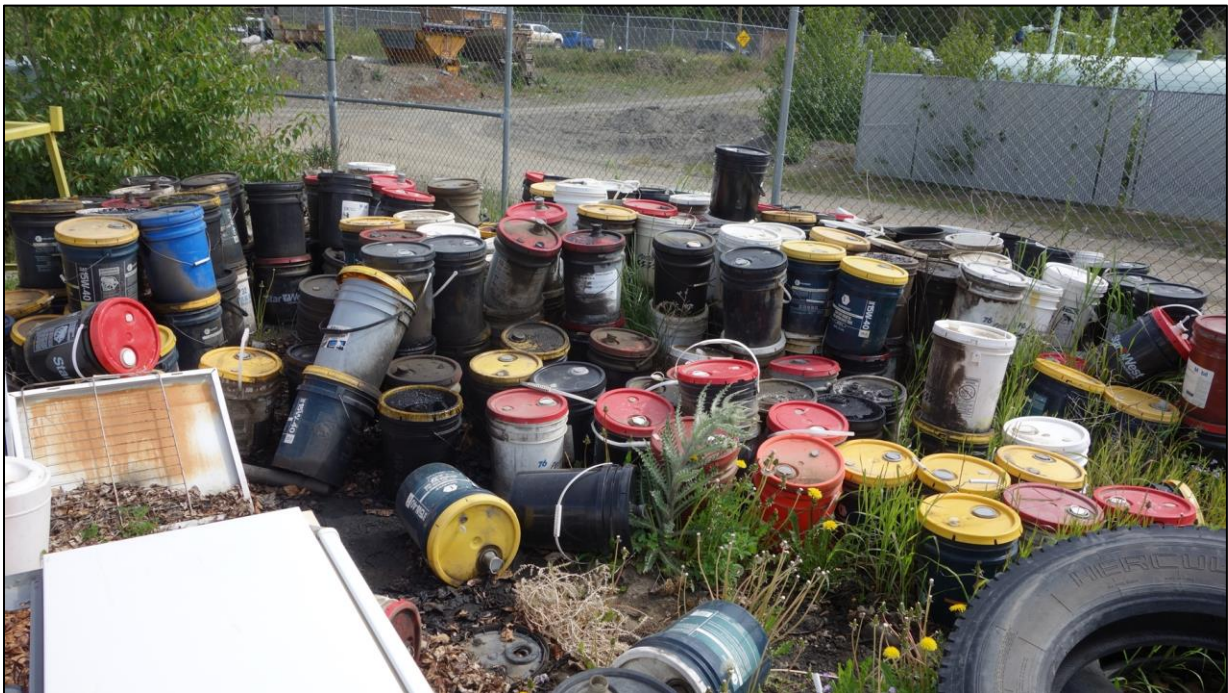
Photograph 8: Waste oil storage and staining in Enterprise Works Yard looking northeast

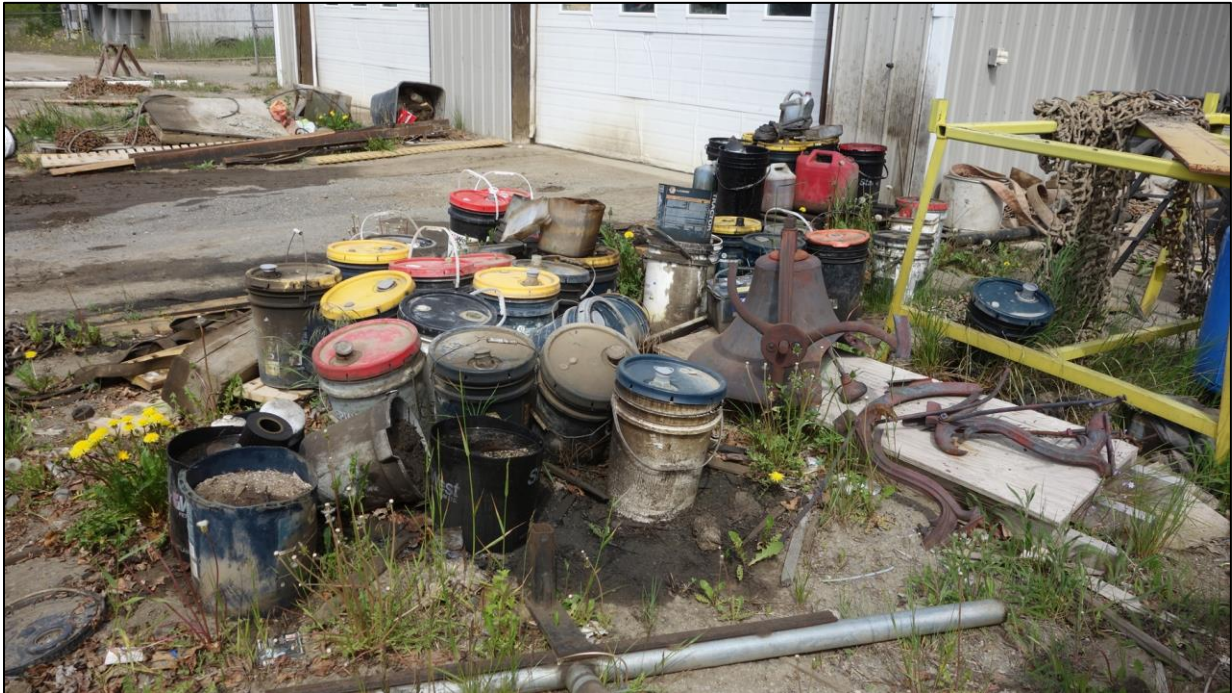
Photograph 9: Waste oil storage and staining in Enterprise Works Yard looking northwest

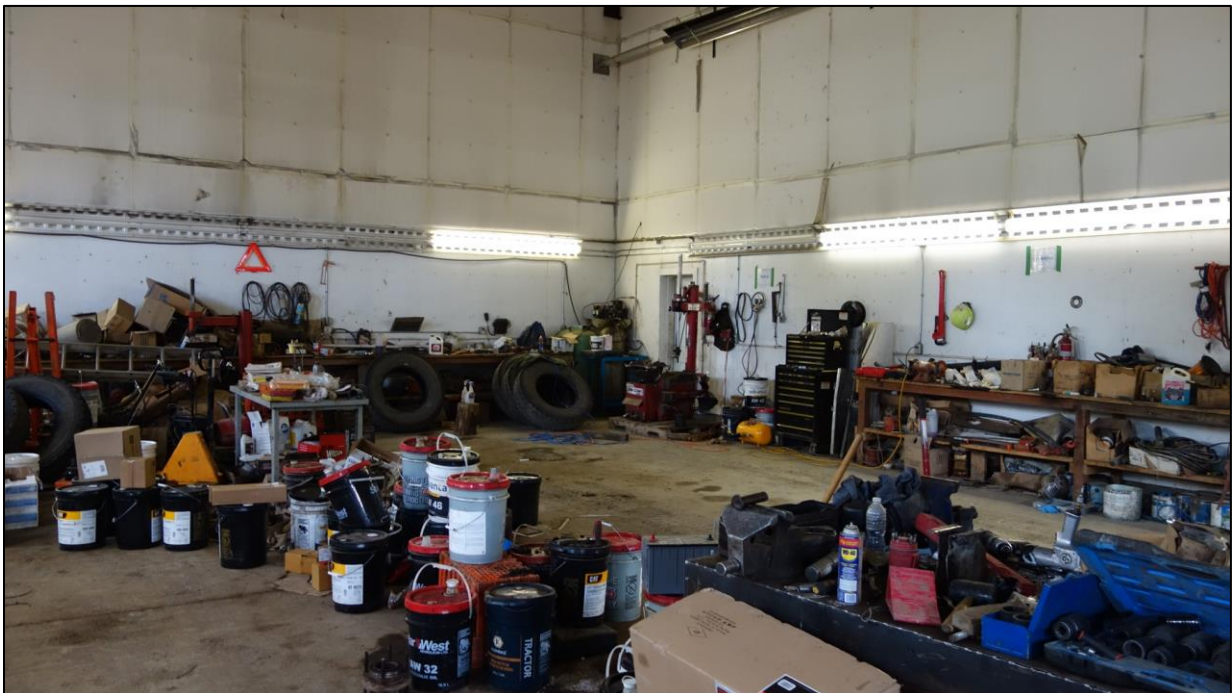
Photograph 10: Inside Enterprise Works Yard shop

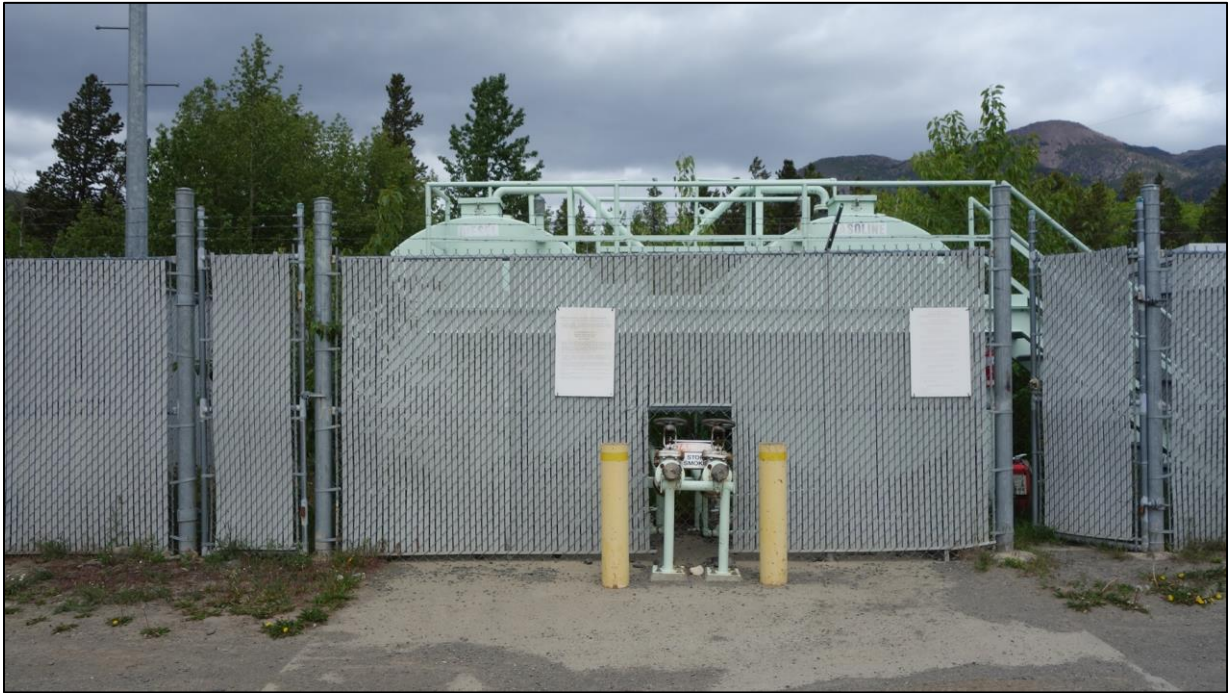
- The gas station has double-walled Enviro-Safe gasoline and diesel ASTs, approximately 30,000 L each, and according to the gas station manager, the tanks are regularly dipped and volume audits conducted, and evidence of leaks of volume discrepancies have not been identified. In addition to the storage tanks, the unpaved area around the fuel pad, the catch basins and associated oil/water separator, and waste oil storage area; are considered to be an APEC.

Photograph 11: Enterprise gas station ASTs looking north

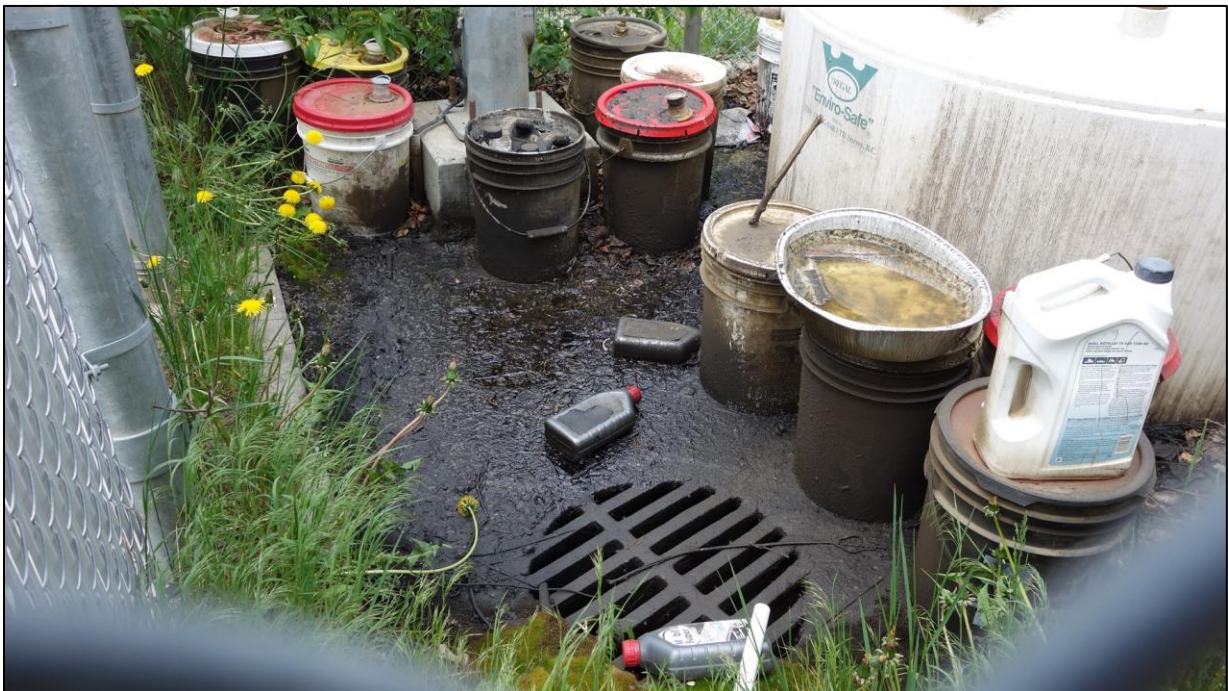
- In 2022, approximately ten 20 L containers and various smaller containers of waste oil were stored, over a concrete pad with a catch basin adjacent to a full waste oil AST (~3000 L) at the Enterprise Gas Station. Thick oil-like staining was observed over the concrete pad and grate to the catch basin (as identified for APEC 1A),

Photograph 12: Waste oil collection at Enterprise gas station

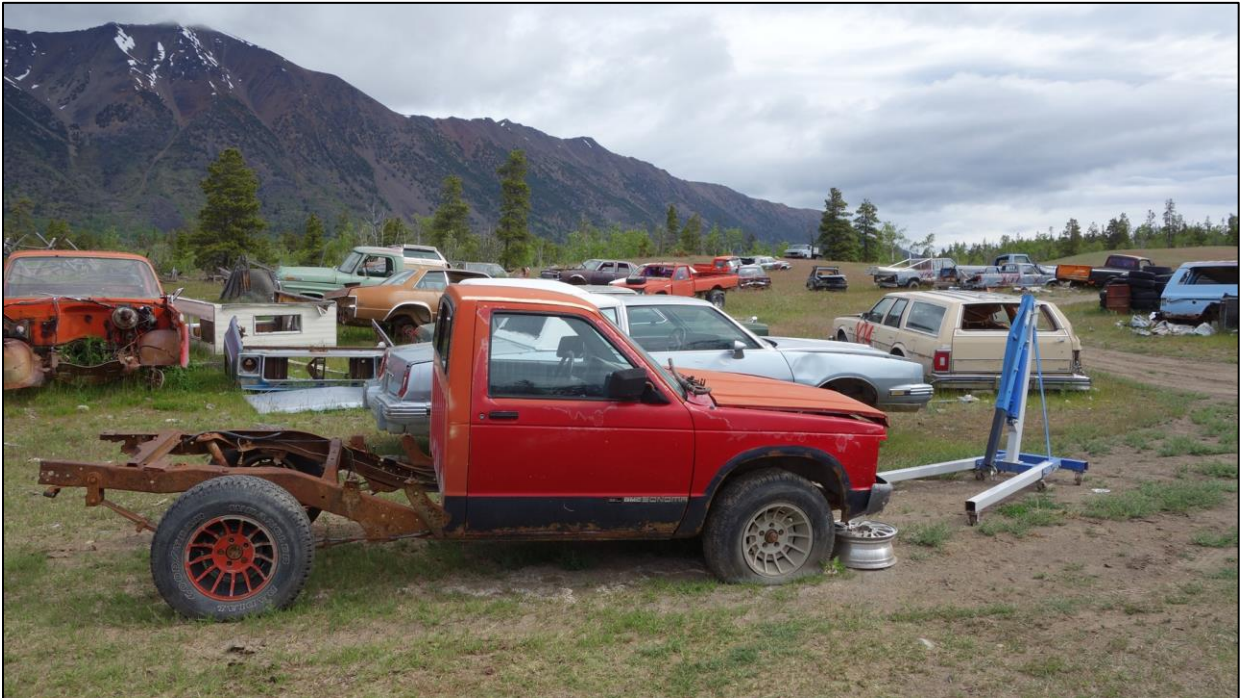
- A FCSI number has not been assigned for this site.
- Approximately 50 derelict cars and small trucks were observed in the pasture in the vicinity of Glen Lulua's residence on the south portion of Garden 2A during the 2022 Site visit.

Photograph 13: Glen Lulua's derelict vehicles on the south portion of Garden 2A looking northeast

- After the vehicles are removed, the grounds should be inspected to observe if significant staining is present to determine if a Phase II ESA is warranted.

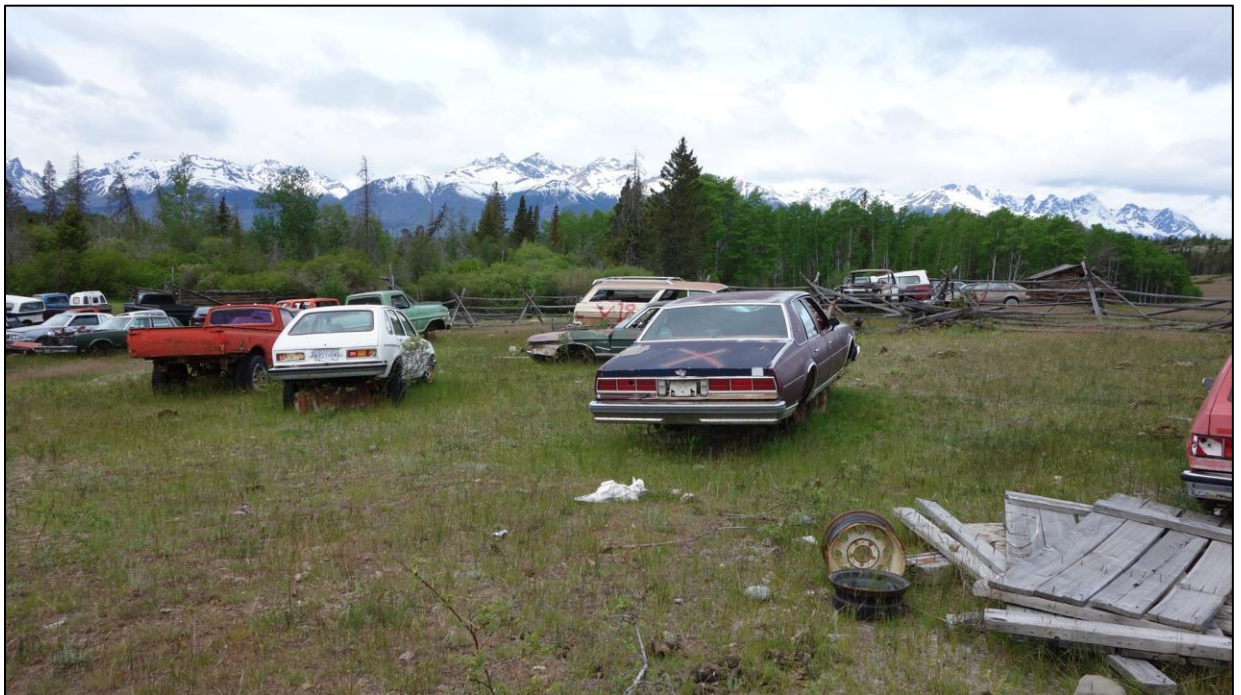
Photograph 14: Glen Lulua's derelict vehicles looking southwest

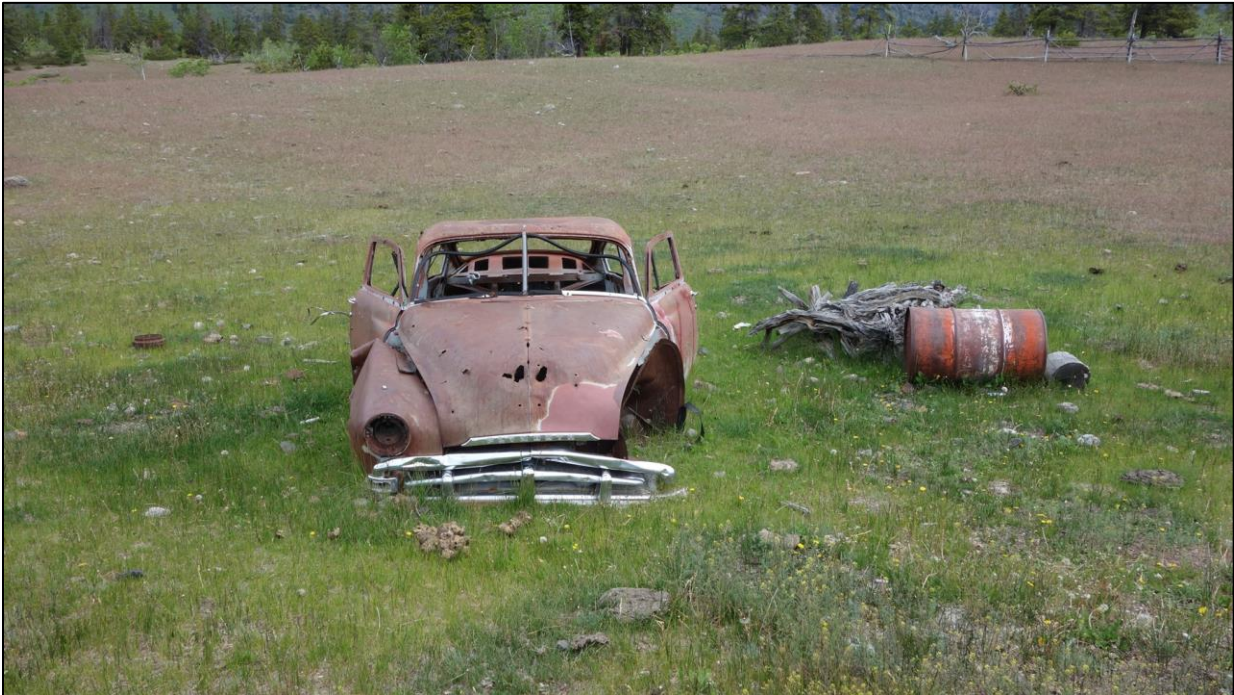
Photograph 15: Glen Lulua's derelict vehicle and drum looking north

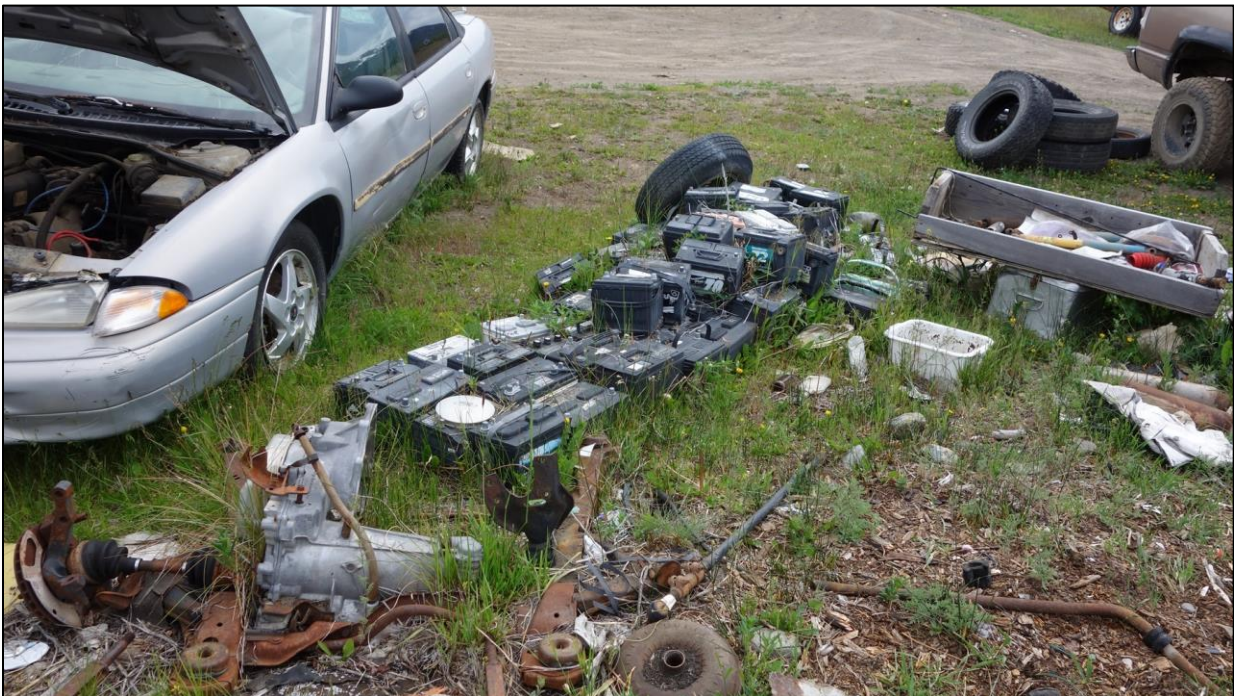
- In addition, various engine parts, empty gas tanks, and approximately 20 batteries were observed on unpaved ground adjacent to the residence.
- With the exception of minor small drips, staining was not observed.

Photograph 16: Vehicle batteries and parts at Glen Lulua's looking east

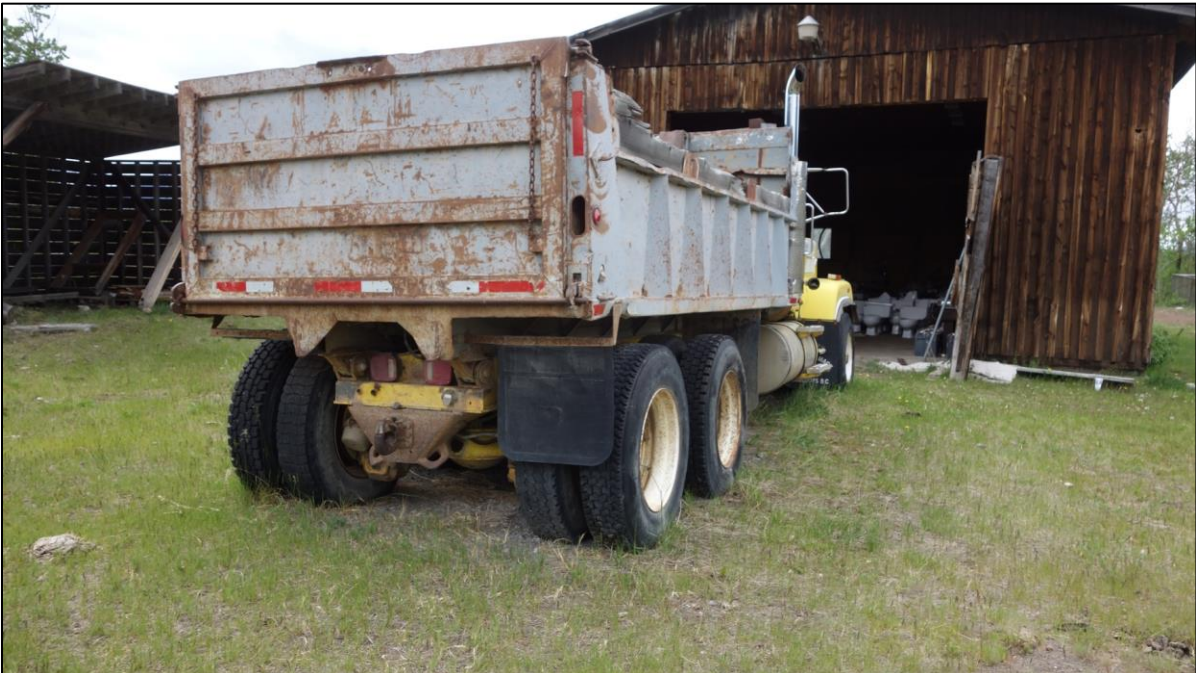
²¹ Used building materials and plumbing fixtures, associated with building renovations and repairs across the Site I.R.s, were observed in the storage building/maintenance shop adjacent to the Community Hall during the 2022 Site visit.

Photograph 18: Maintenance shop/storage building adjacent to the Lezbye 6 community hall looking southwest

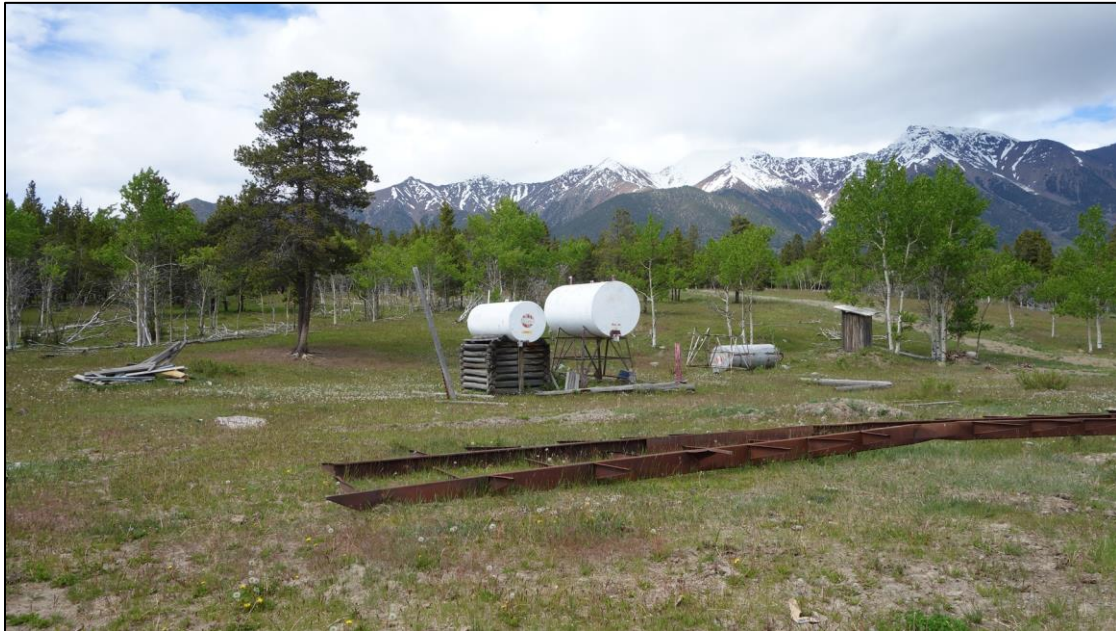
Photograph 19: Current location of William Lulua's (former gas station) ASTs, located at the centre of Chilco Lake 1A, looking northeast

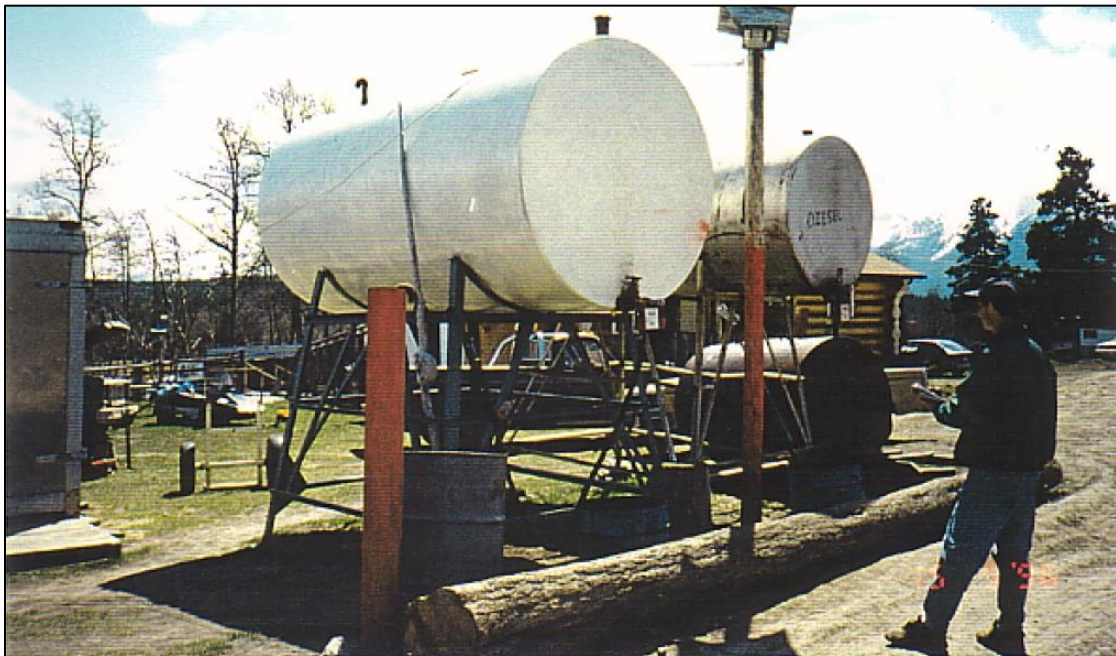
Photograph 20: Former location of William Lulua's ASTs in 1996 looking southwest²

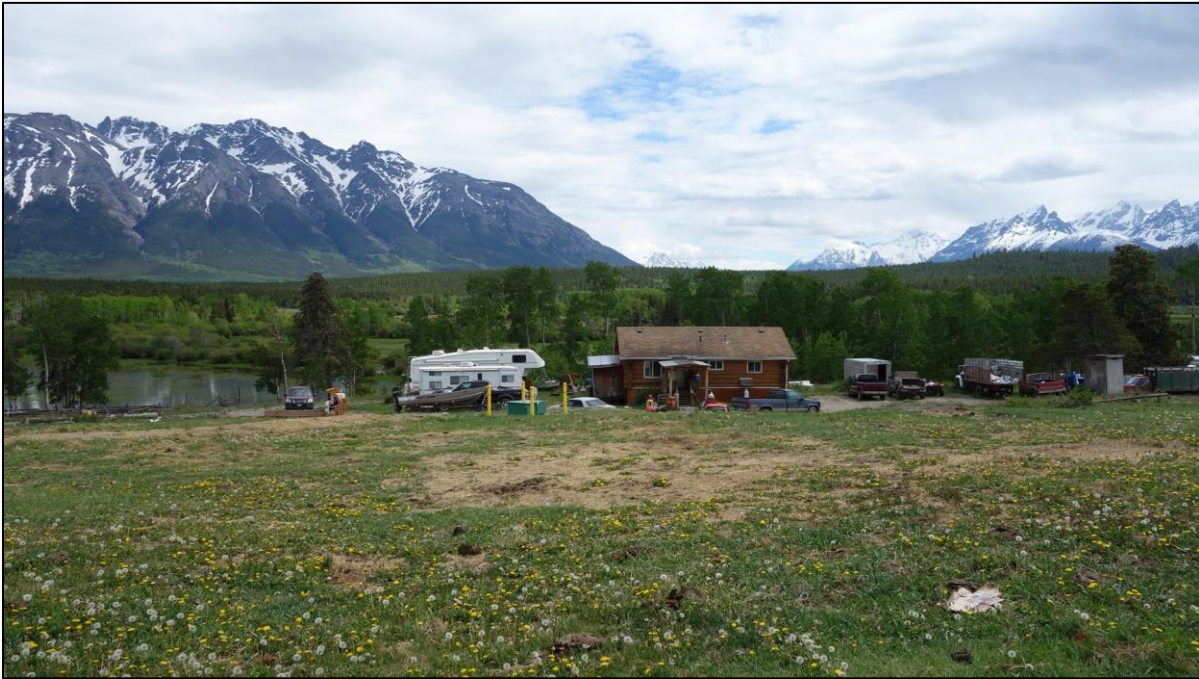
Photograph 21: Vicinity of the former location of William Lulua's gas station ASTs in 1996 (foreground), located ~20 m south of the existing location of the ASTs, looking south

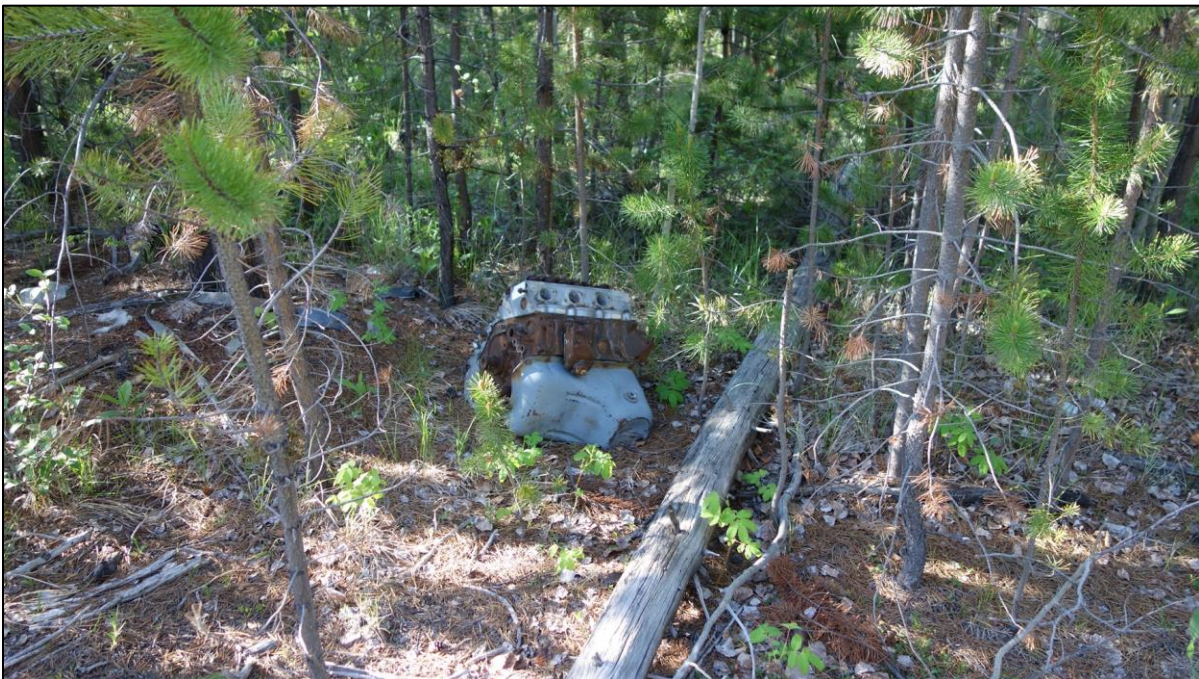
Photograph 22: William Lulua's dump, located ~300 m north of the former William Lulua gas station, on the north central portion of Chilco Lake 1A, looking east

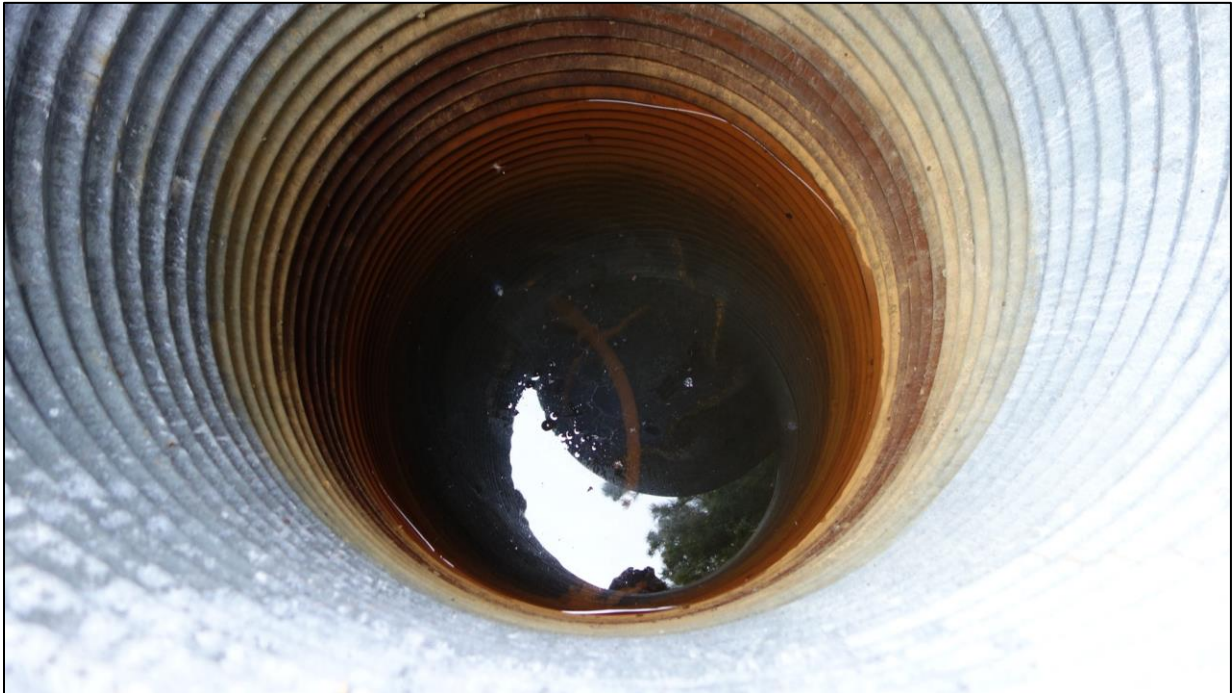
Photograph 23: Robin Lulua's well on the southwest portion of Chilco Lake 1

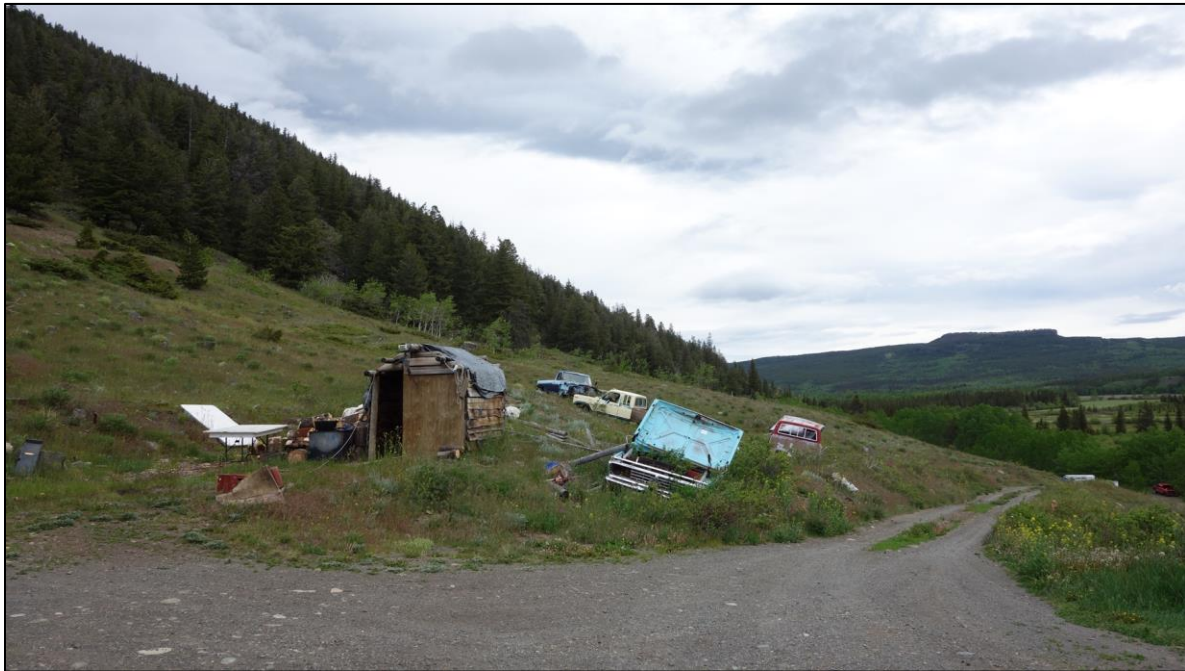
Photograph 28: Derelict vehicles on northwest portion of Tanakut 4 looking east

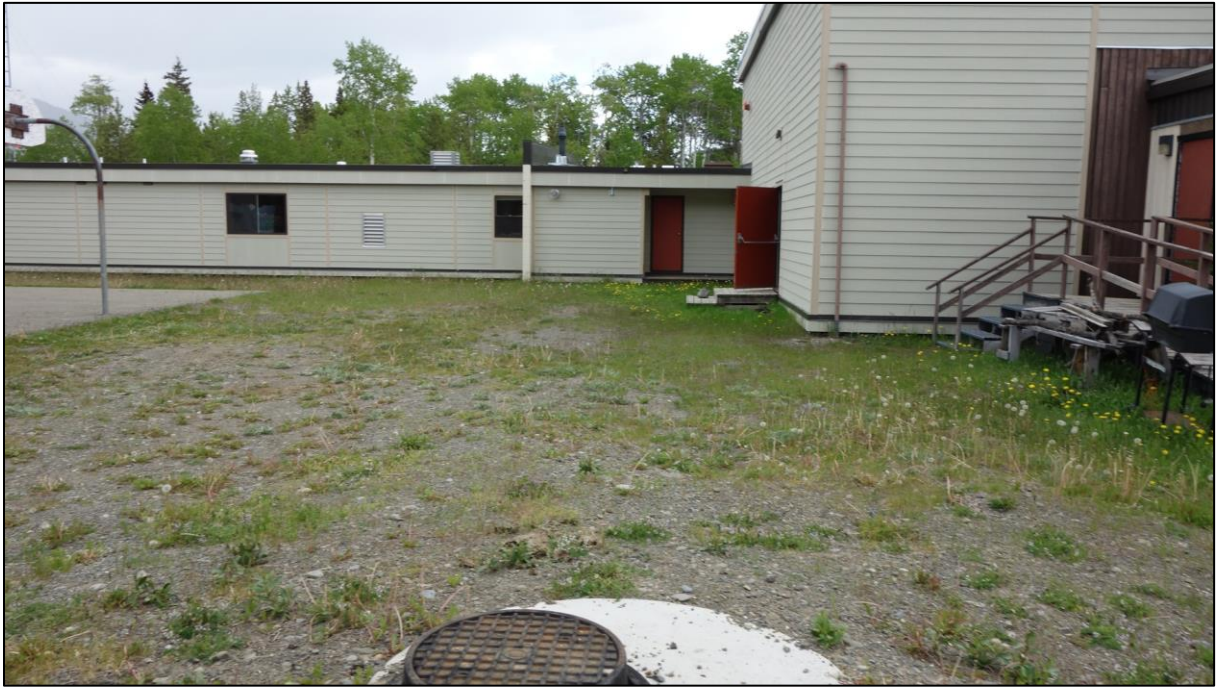
Photograph 31: Vicinity of UST at Naghtaneqed School, located adjacent to the west of Lohbiee 3, looking east
